BYERS PIPE

BULLETIN No. 30

An Investigation of Pipe Corrosion

Showing service records of iron, steel
and brass pipe used for hot and cold
water supply lines in 129 Pittsburgh
Apartment Buildings

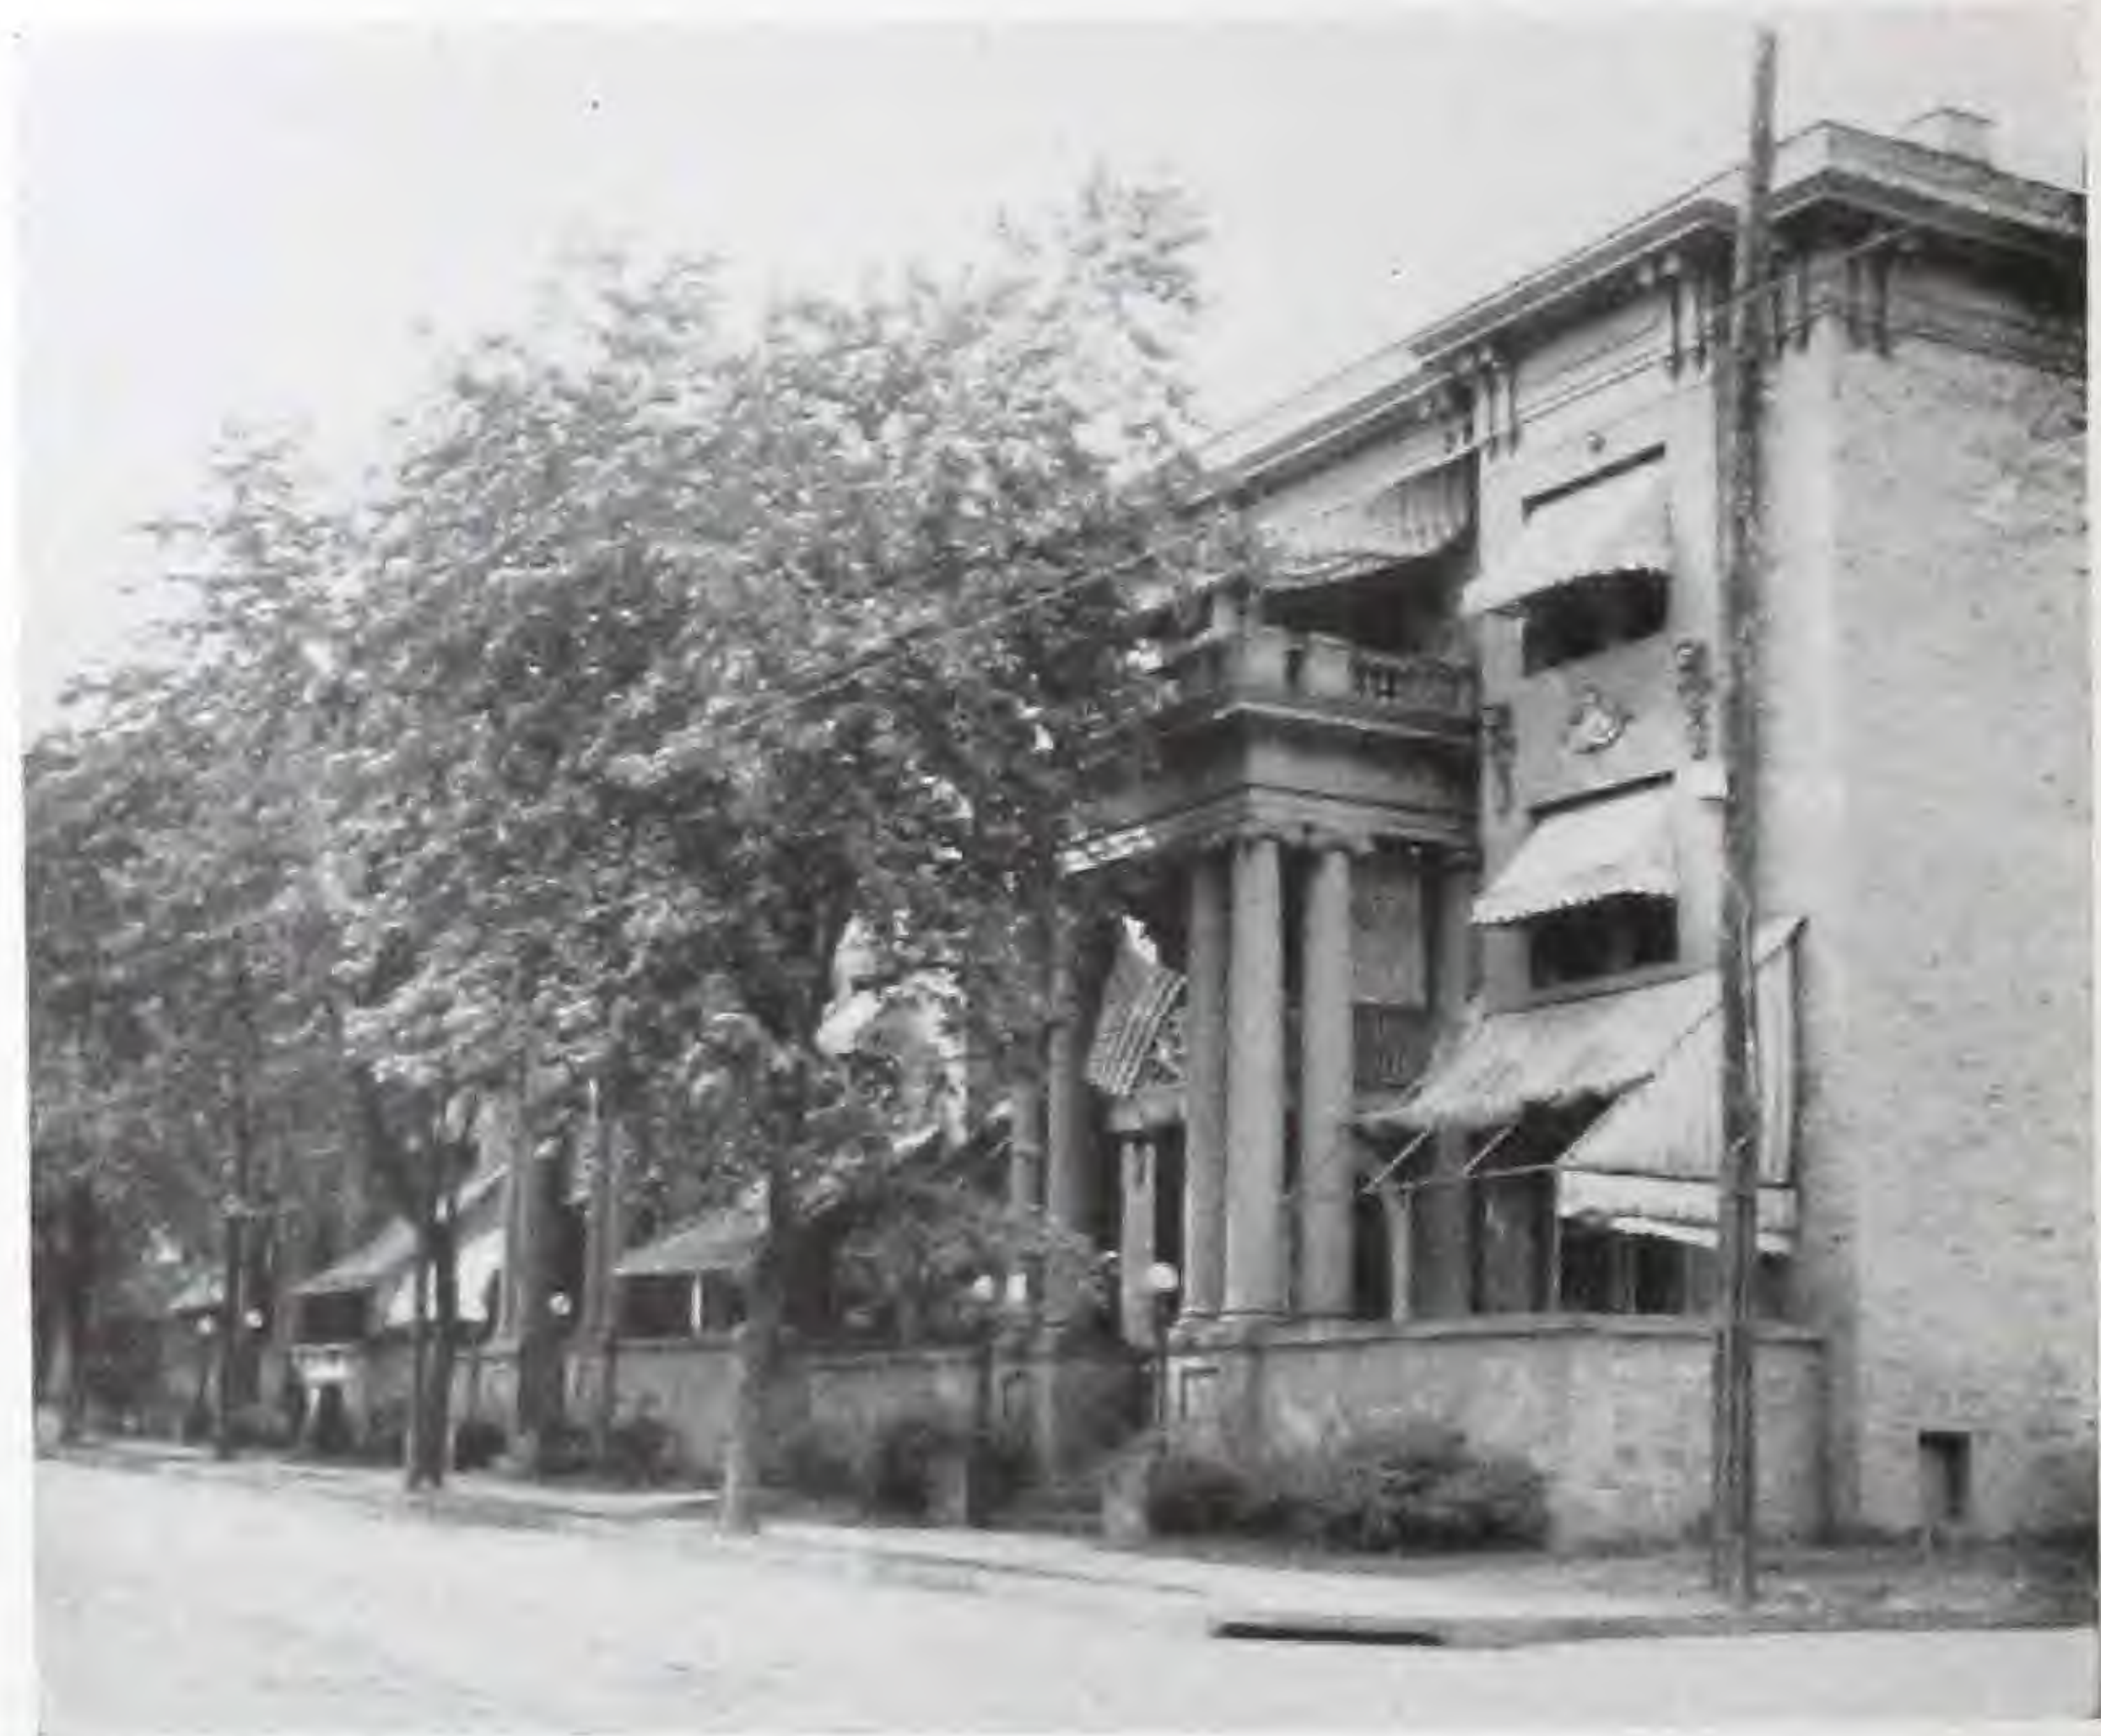
The Lexington, Argyle, and Drexel Apartments, erected 1909. Equipped with steel pipe. Life of hot water mains, 7 or 8 years. See records Nos. 13, 14 and 15, page 14.

13. Drexel Apts. Penn near Homewood.	6	1909	Hot water mains and 1 riser replaced winter 1916-17.	7 yrs.	Small repair after 7 yrs.	8 yrs. Still good
14. Argyle Apts. Penn near Homewood.	6	1909	Part of hot water mains in basement replaced 1915.	s-8 yrs.	8 yrs. Still good	8 yrs. Still good

15. Lexington Apts. Penn and Lexington.	6	1909	Part of hot water mains replaced in basement 1916.	s-8 yrs.	8 yrs. Still good	8 yrs. Still good
16. Wm Pitt Apts. S. Negley and Elmer.	12	1911	Hot water mains badly corroded. Installed filter 1915 to eliminate rust, but did not accomplish purpose.	Filters 6 yrs. Still good	6 yrs. Still good	6 yrs. Still good

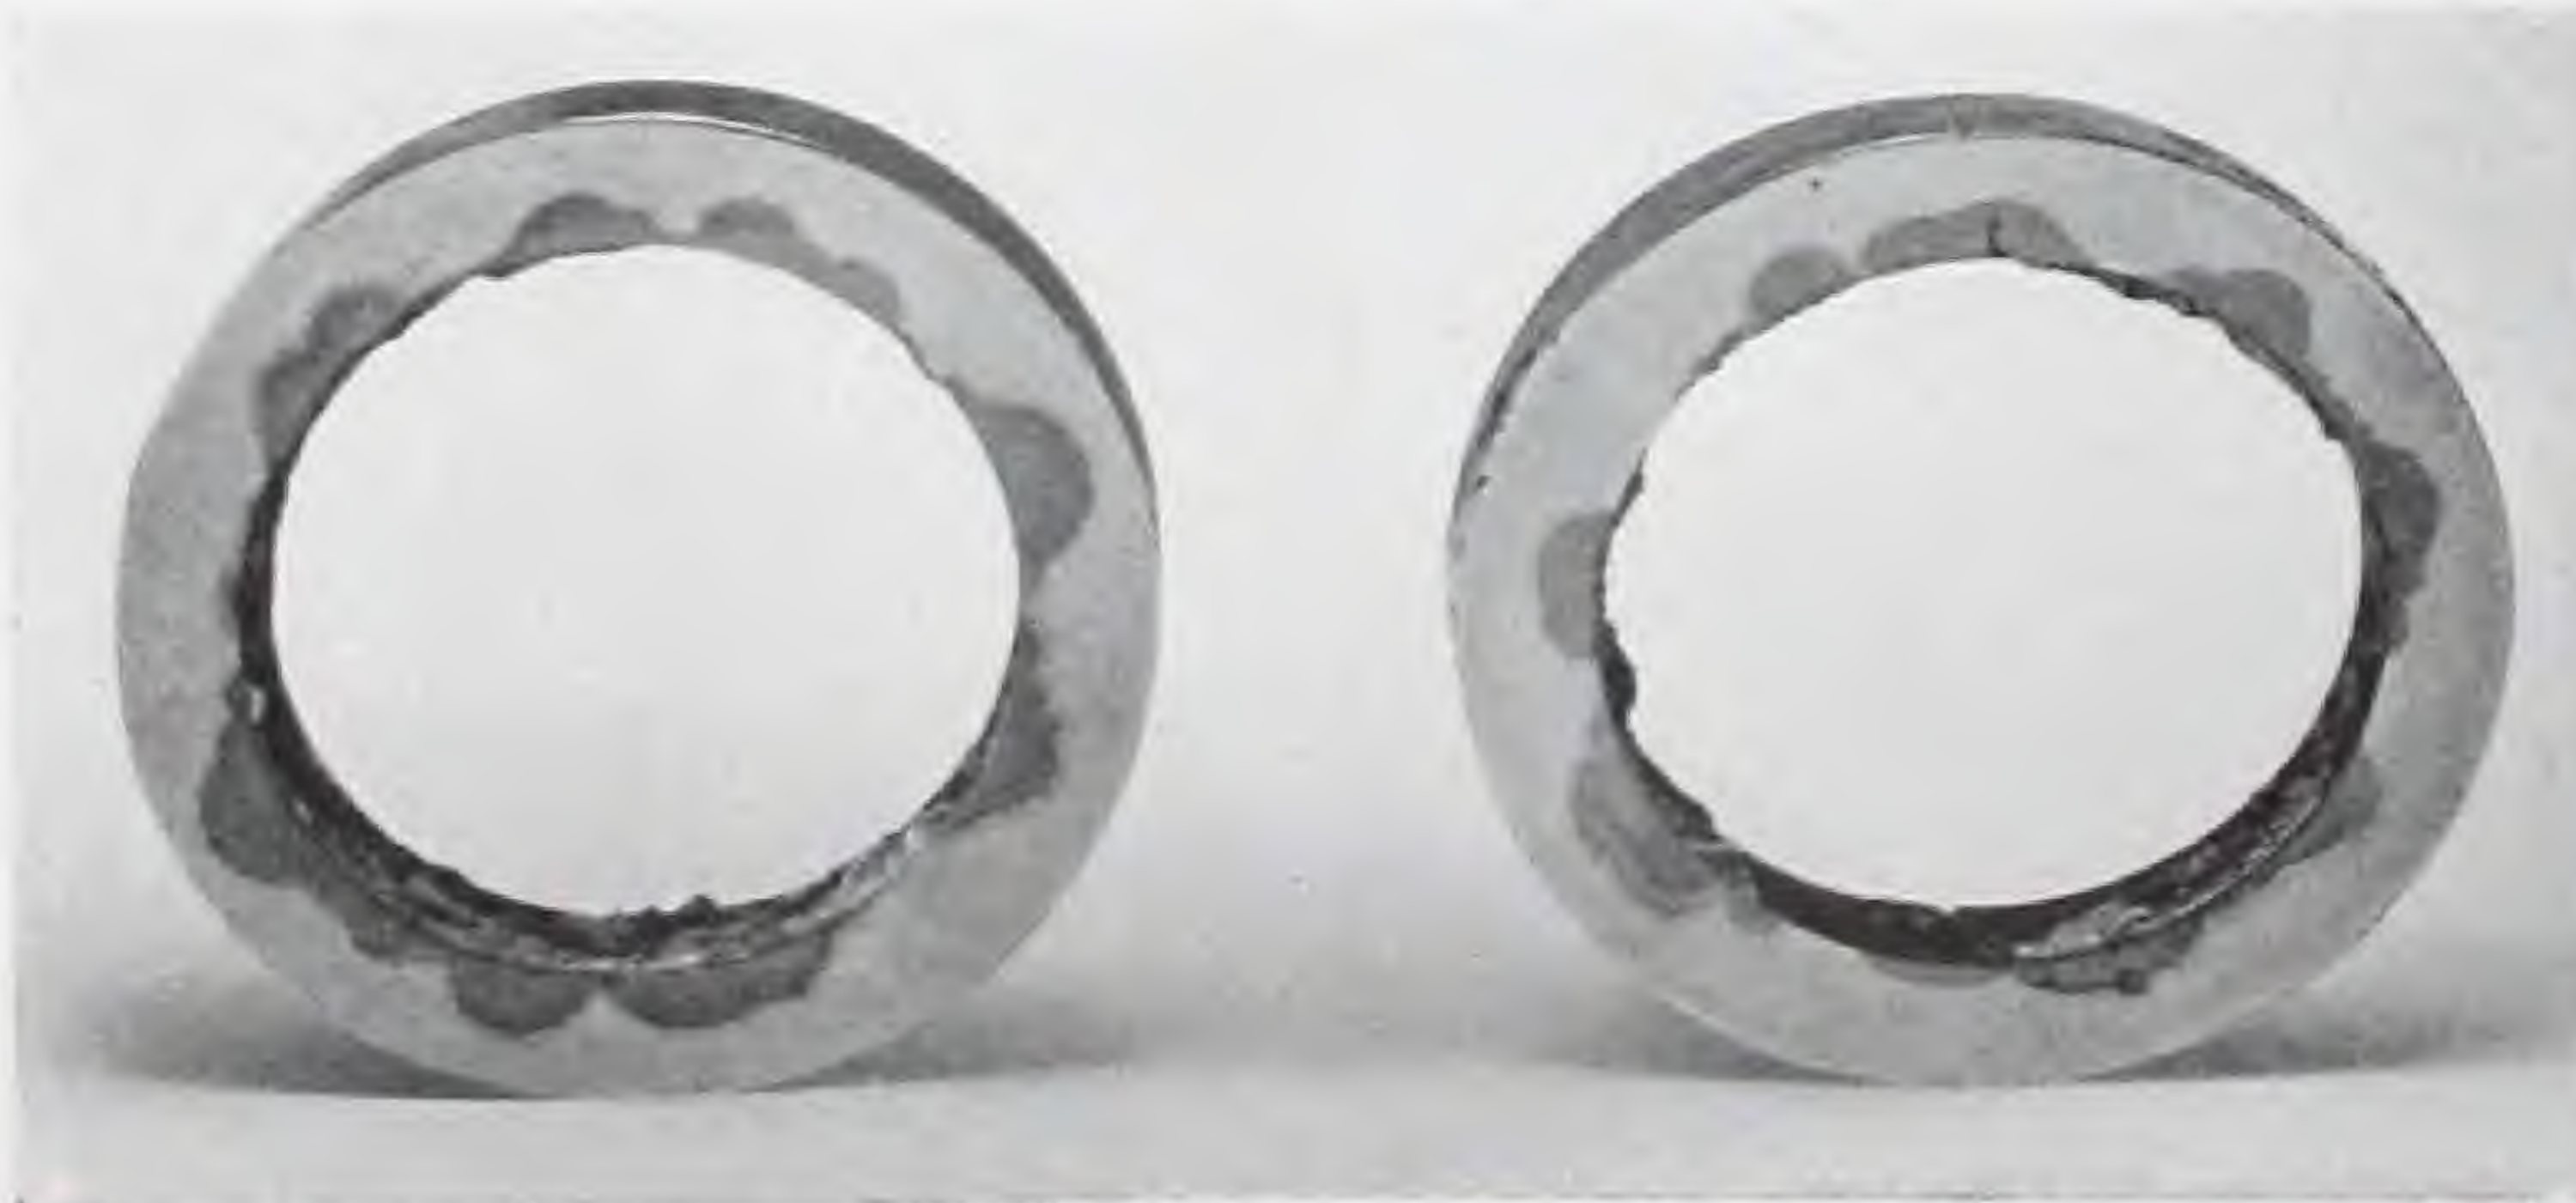
Typical condition of pitted brass pipe after 10 years' service in hot water mains.

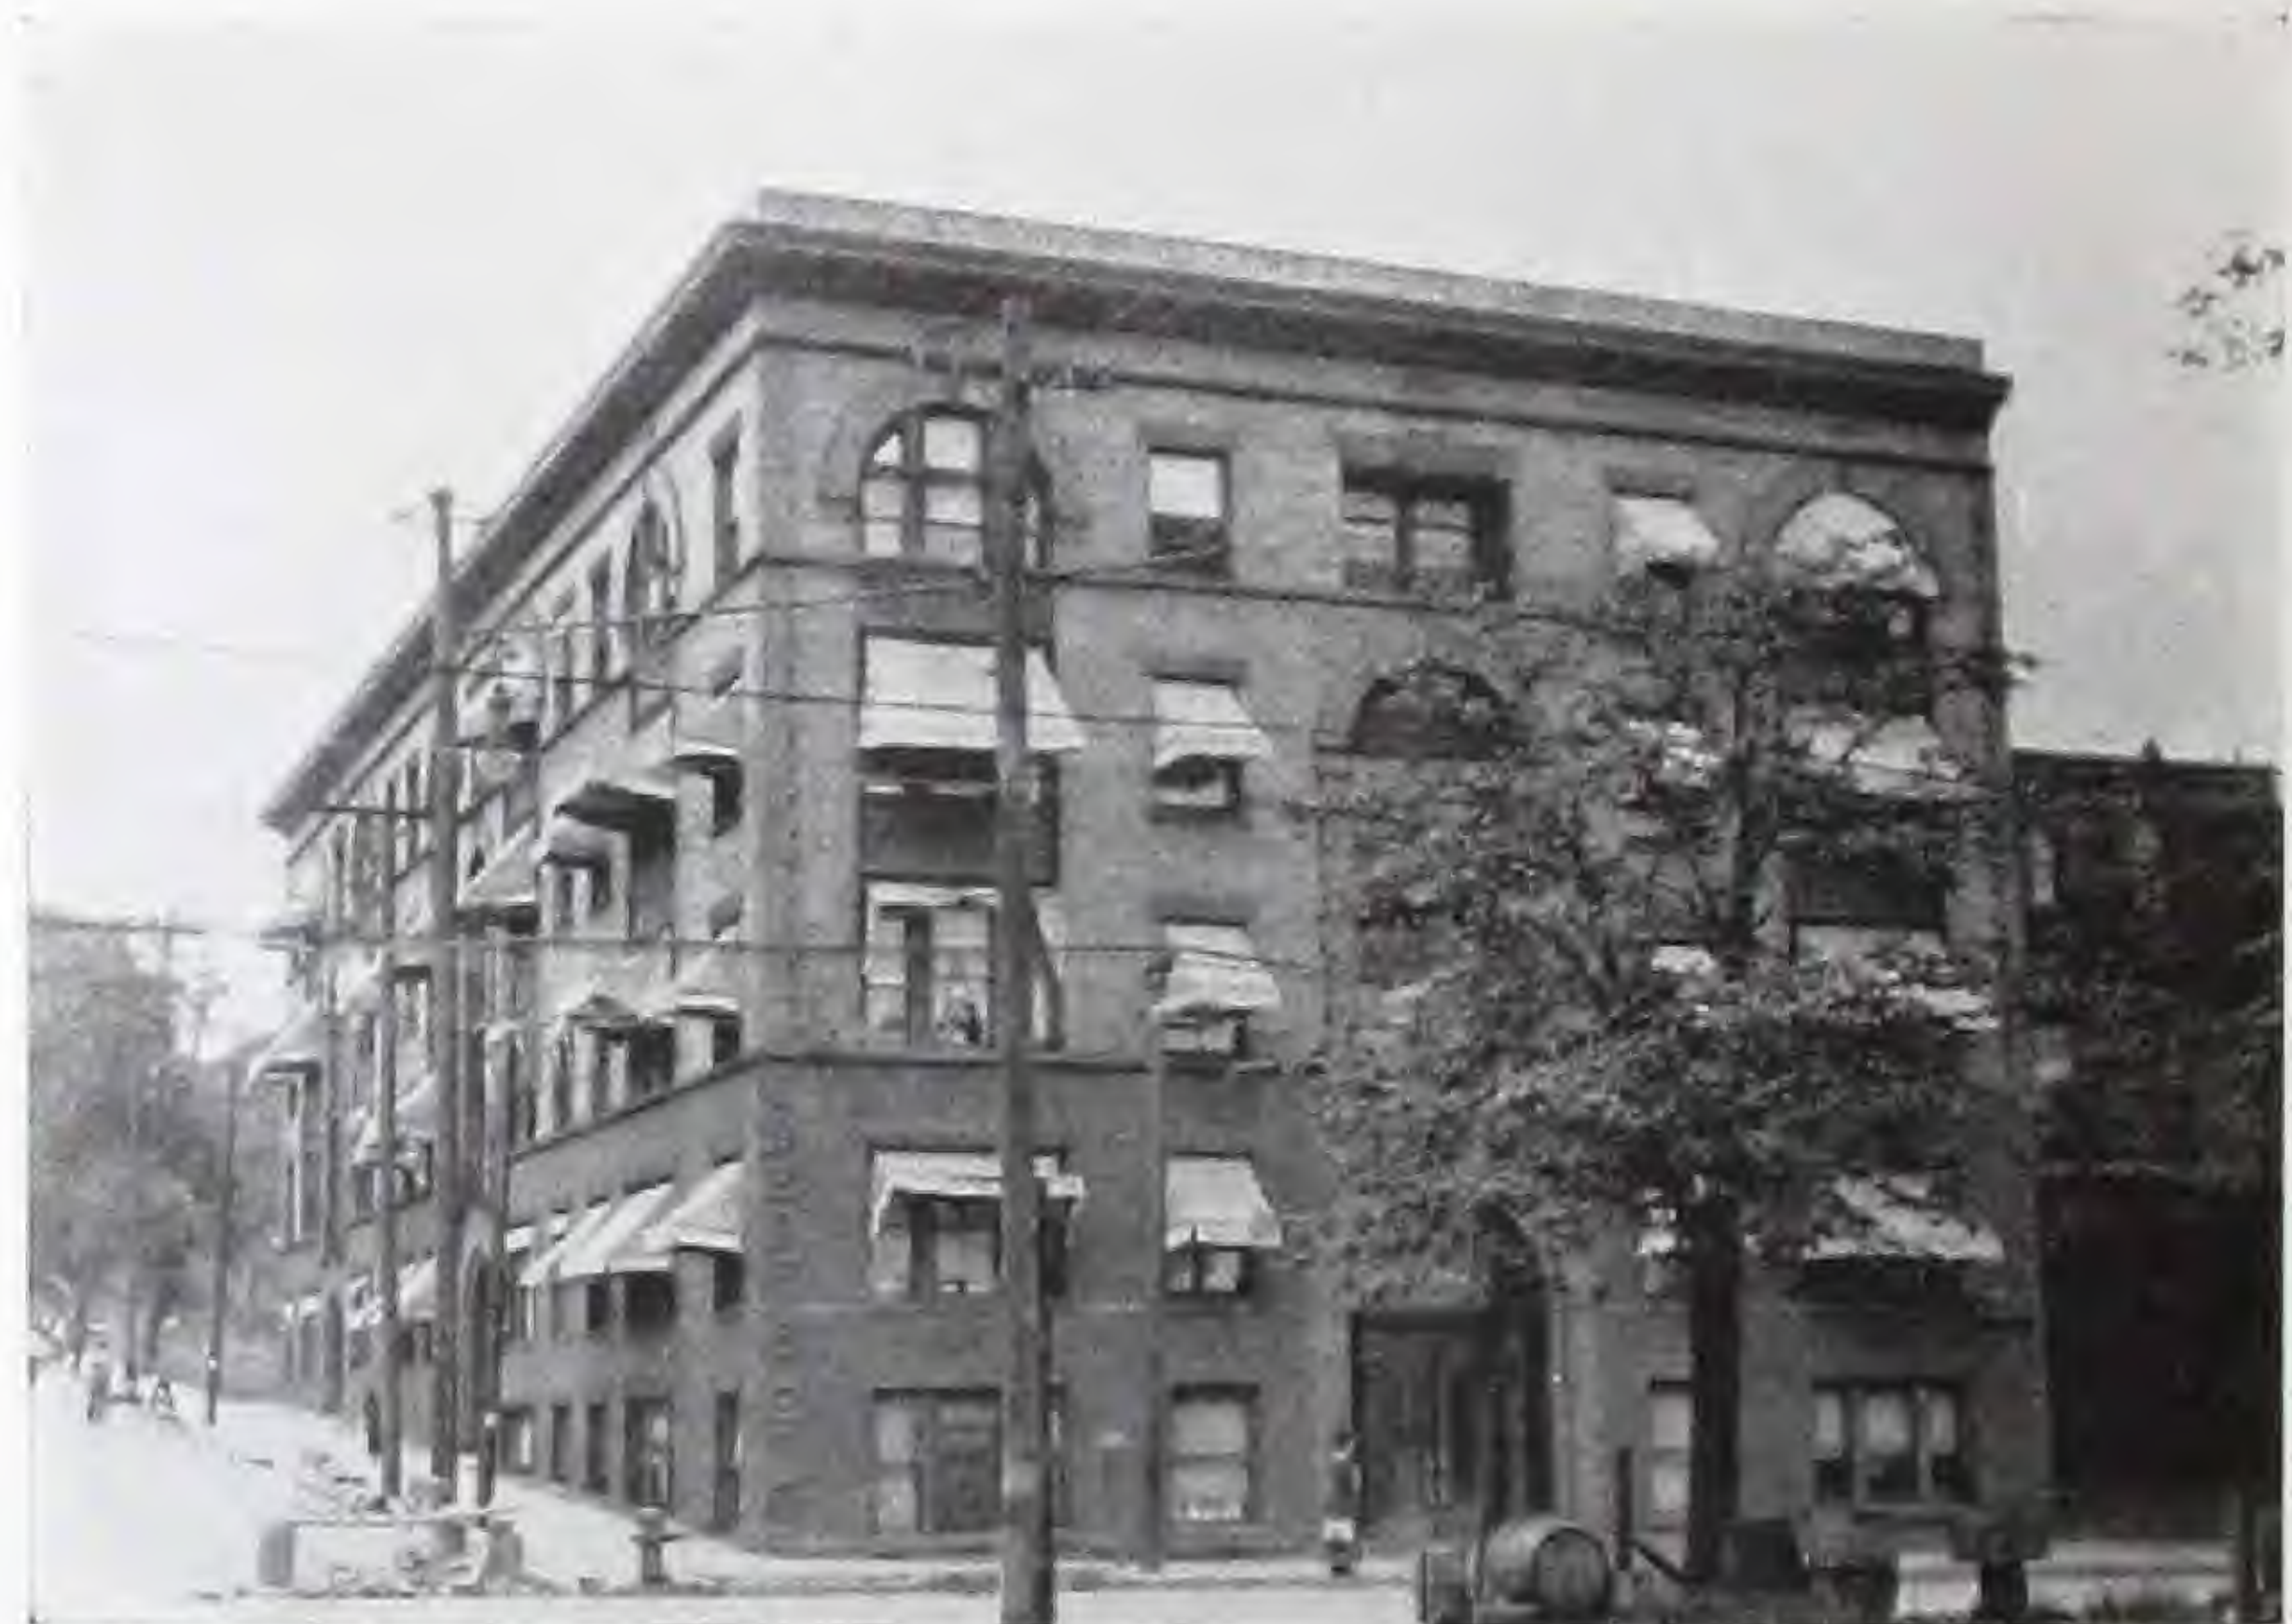
Oakland Apartments, Halket and Forbes Streets, erected in 1902, and equipped with wrought iron pipe, all of which is still in good condition, excepting the hot water mains which now needed replacement after 15 years' service. See record No. 55, Wrought Iron Installations, page 17.

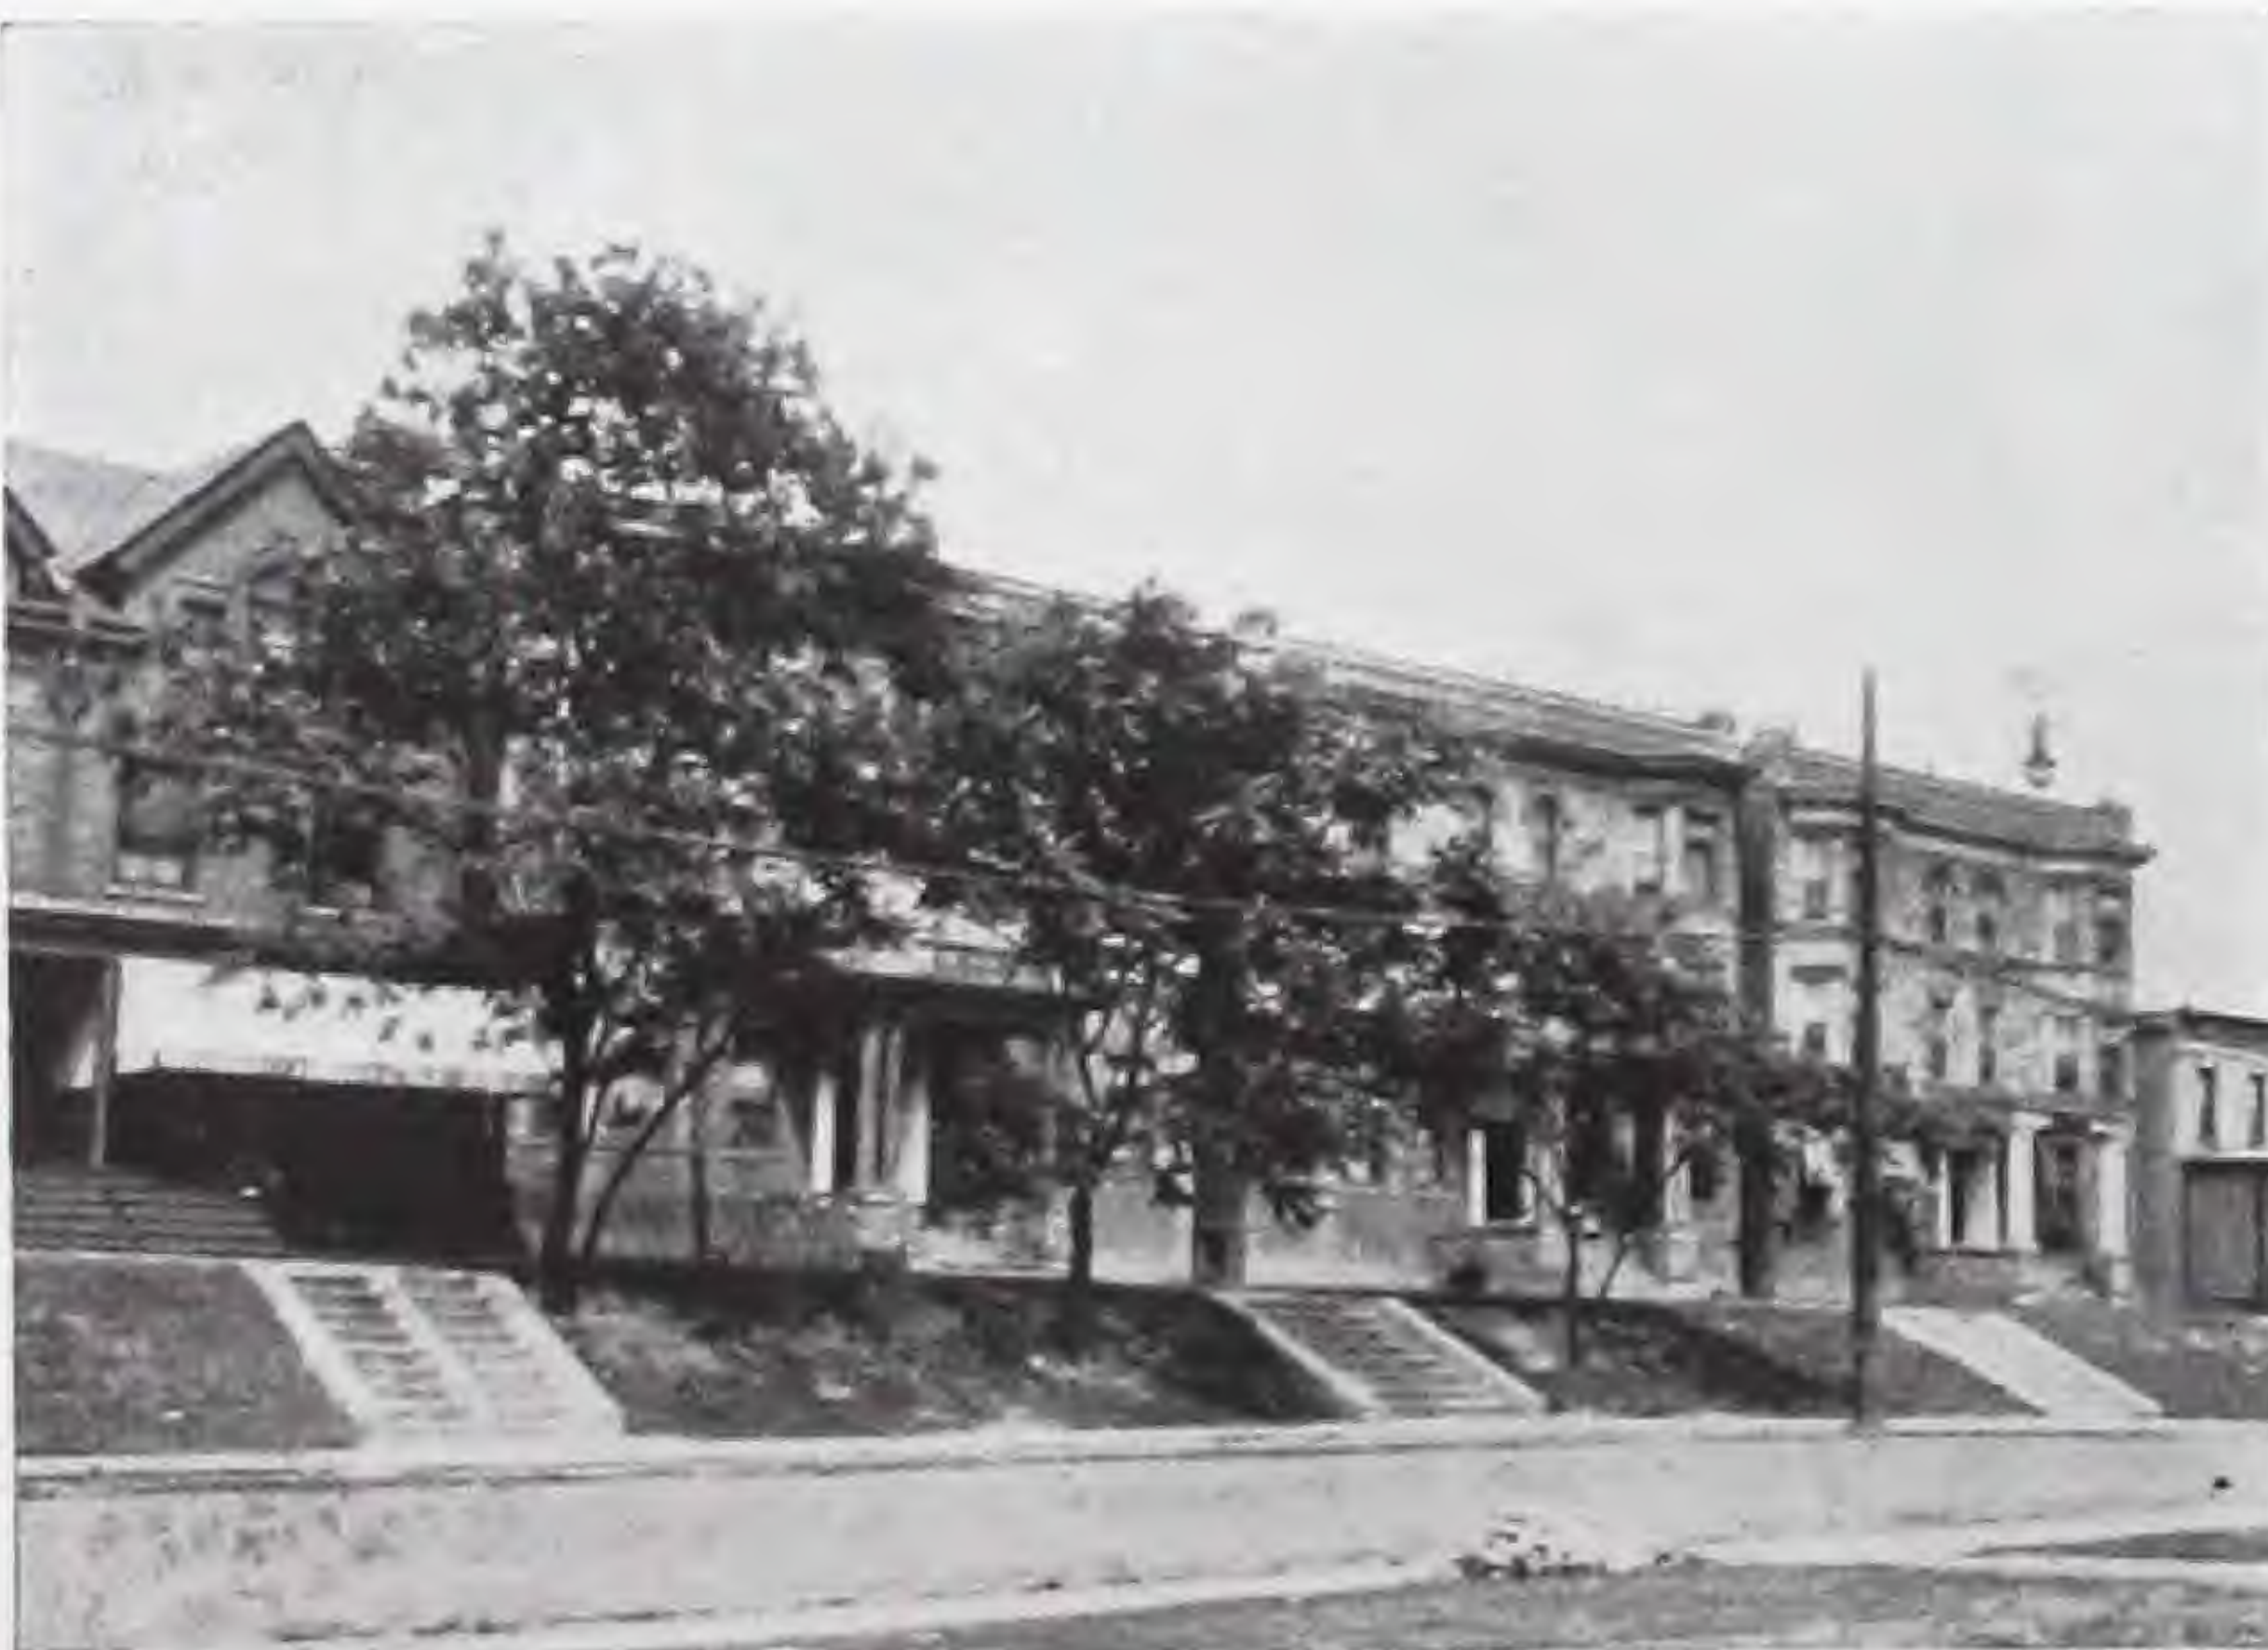
Yellow Brick Apartments, erected 1902. Equipped with wrought iron pipe. Hot water mains needing replacement after 14 years' service. See records Nos. 43 and 44, page 16.

43. Yellow Brick Apt. McKee Place.	12	1902	Repairs started in 1915. Entire basement hot water piping now needs replacement.	14 yrs.	14 yrs. Still good	14 yrs. Still good

44. Yellow Brick Apts. No. 2. McKee Place.	6	1902	Some of hot water mains replaced, all now need replacement.	14 yrs.	14 yrs. Still good	14 yrs. Still good

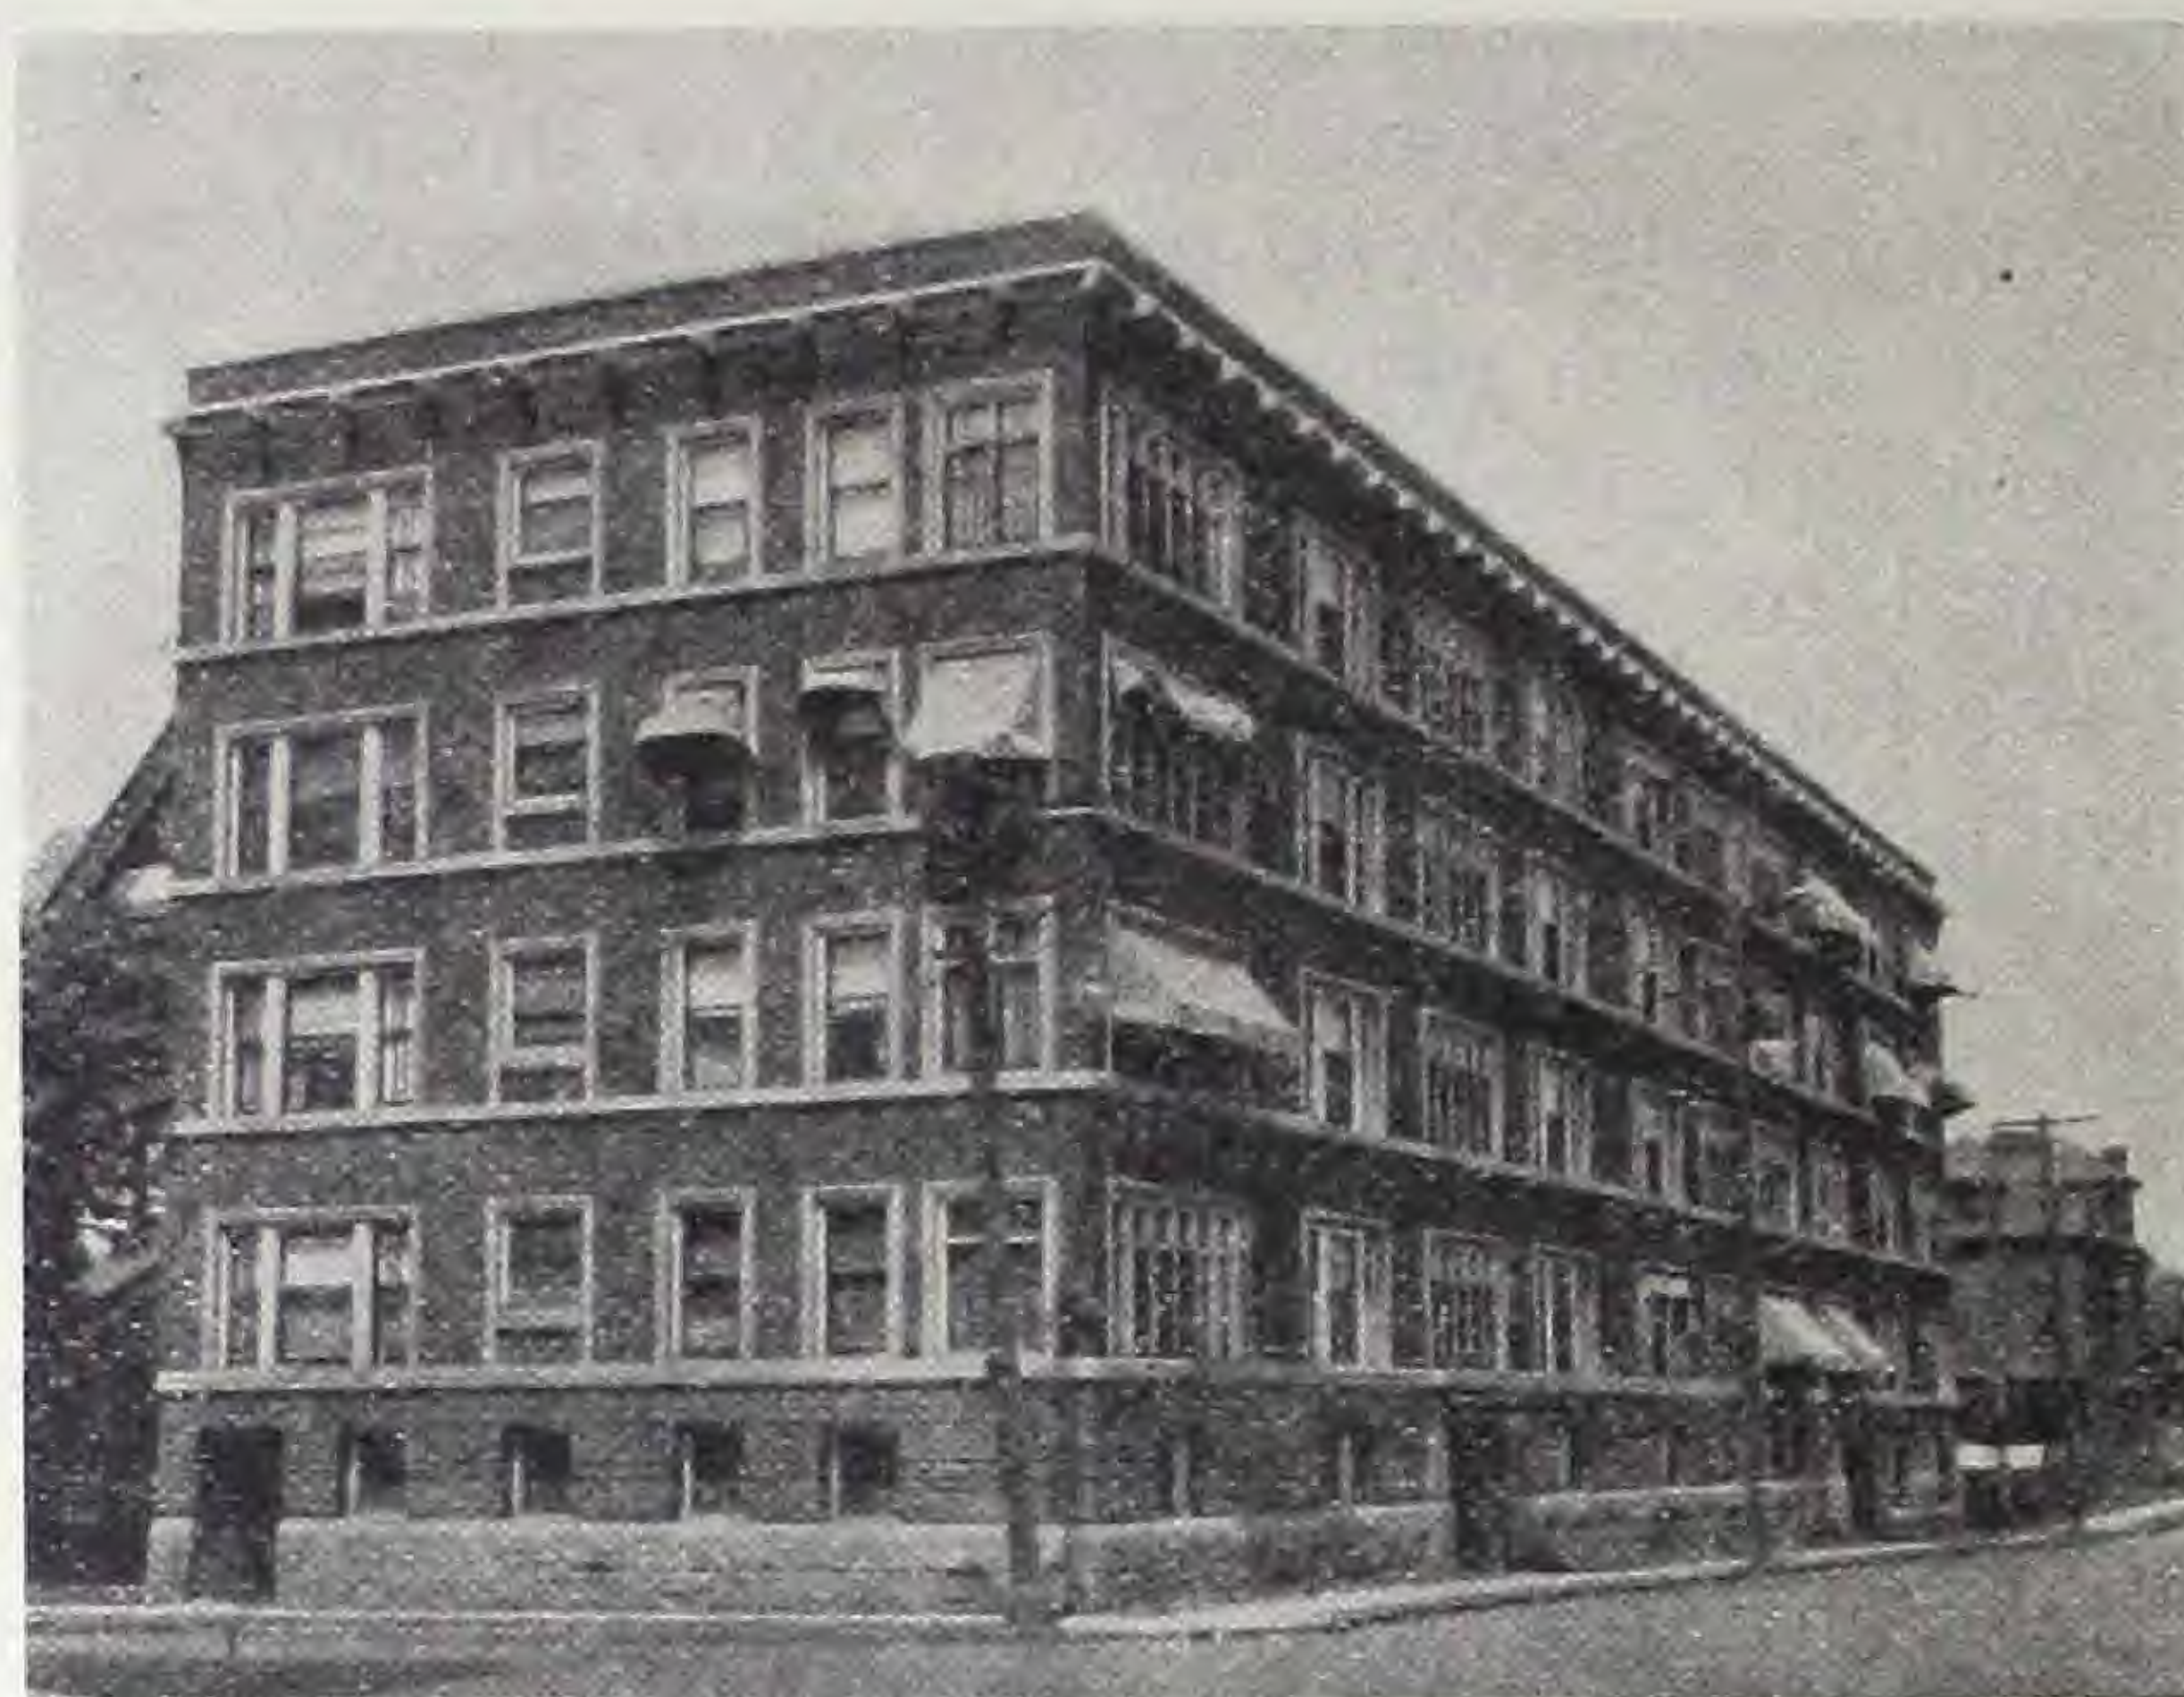
The Netherlands Apartments, Summerlea and Elwood, erected 1911, equipped with steel pipe. The hot water soon became so rusty that filters were installed in 1916. These filters, however, have not eliminated the rust from the water. See record No. 20 on page 15 and also paragraph on "Rusty Water" on page 7.

20. Netherlands Apts. Summerlea and Elwood.	20	1911	Filters installed 1916 to eliminate rusty water, but did not do so. Hot water mains partly replaced, and 1 riser entirely replaced.	s-8 yrs.	See Remarks	6 yrs. Still good
